BHDT Corrosion Inspection Services

at Nitrogenmuvek Zrt. Hungary Urea Plant

BHDT Service
Mr. Michael Simml

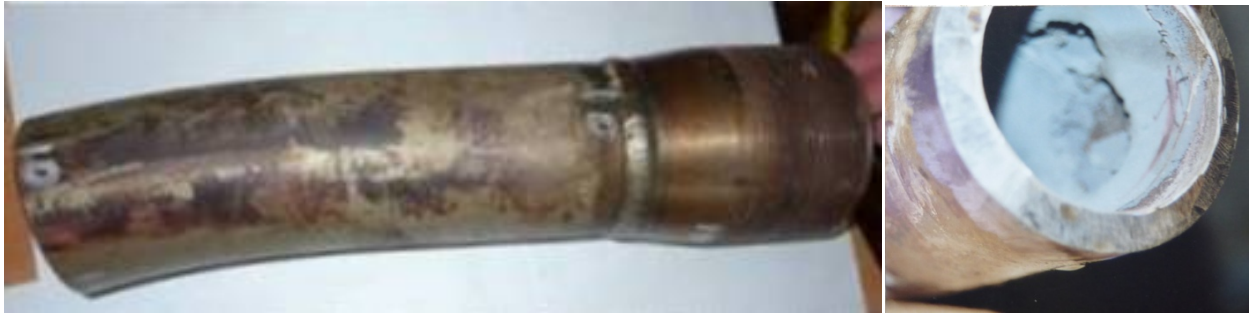
Picture 6a/b: The corroded 3" pipeline used for validation of the Digital Radiography Technique

The pictures above show the 3" pipeline part, which was replaced earlier due to heavy condensation corrosion. It is a 3" high pressure pipeline, material of construction 316L UG with the following dimensions 88,9 X 11,13 mm. Ultrasonic wall thickness measurements showed a minimum thickness of 3 to 4 mm with an accuracy of ± 1 mm.

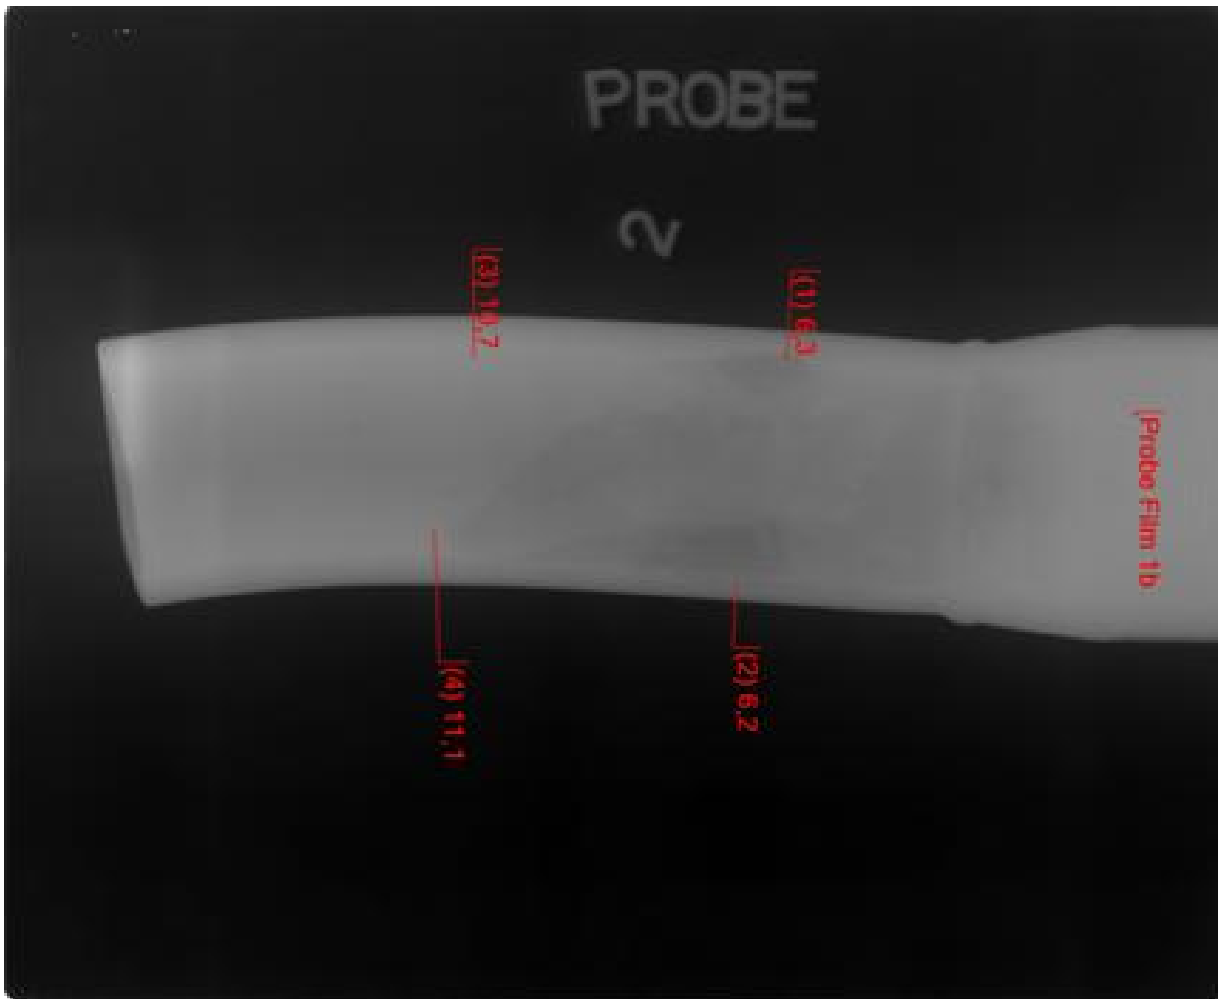
Picture 7: Digital Radiography film of the 3" pipe part

After taking two films with Digital Radiography the minimum measured wall thickness was 6.2 mm, while after four films the minimum measure wall thickness found was 4.6 mm (accuracy of $\pm 5\%$).

1. Differences in darkness qualitatively indicate a decrease in wall thickness
2. In case of a local attack several Digital Radiography films are needed to find the minimum wall thickness.
3. Know How of corrosion phenomena is therefore vital for correct position of source and film

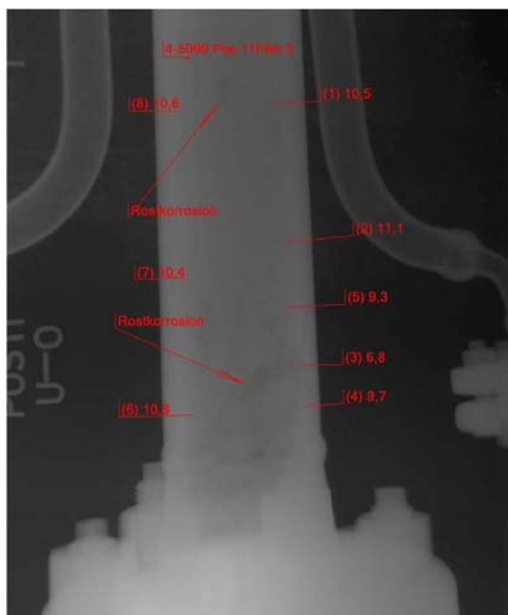
Picture 8: Digital Radiography film of the 3" pipe line

- Inspection of the critical areas of the 3" pipeline shows that at several locations severe condensation corrosion has taken place.
- The corrosion rate is questionable since this type of corrosion is a result of bad insulation.
- The measured remaining wall thickness is at several locations lower or close to the minimum required wall thickness.
- In some occasions the steam tracing impaired a correct wall thickness measurement.

Clearly one is able to see the flange with the bolts and nuts and the two steam tracing lines. Please remind the line is in operation and the insulation is in place. A little more difficult but still clear enough (certainly on the original film) also one can see the areas in the 3" line with a darker grey/black color showing the areas with a smaller wall thickness. 6.8 mm is measured as the minimum wall thickness on one of these areas, which corresponds to the minimum required wall thickness of a 3" High Pressure Pipeline under these operating conditions.

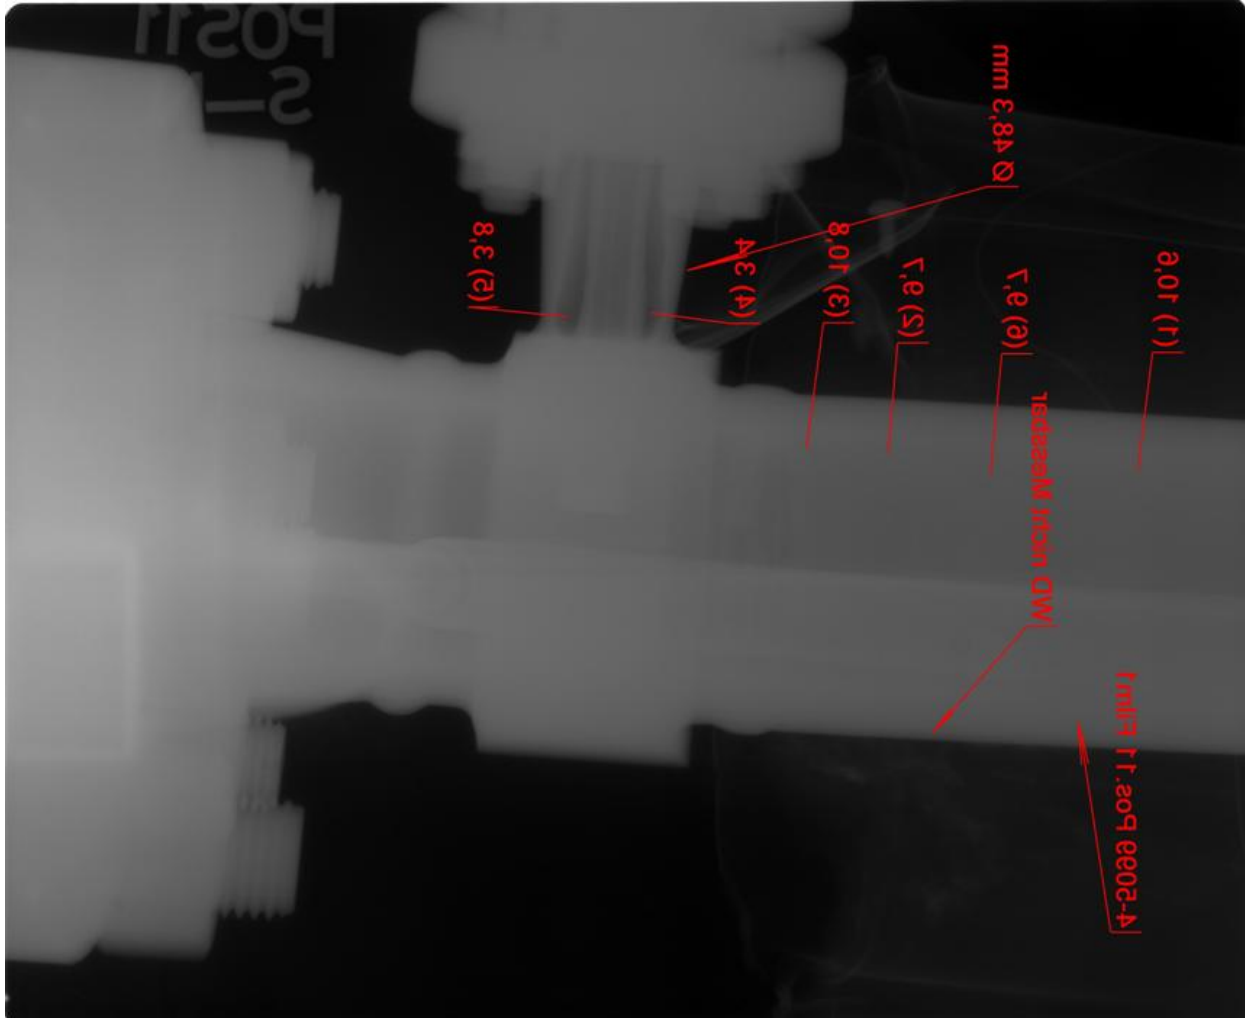
Picture 9: Digital Radiography film of a Tee of the 3" pipe line

The picture above shows the Digital Radiography film of another part of the 3" pipeline. Here one can see a serious wall thickness reduction of the wall of the Tee to a level of 3.4 to 3.8 mm. Condensation corrosion has taken place as such a Tee can easily act as a cold spot area.

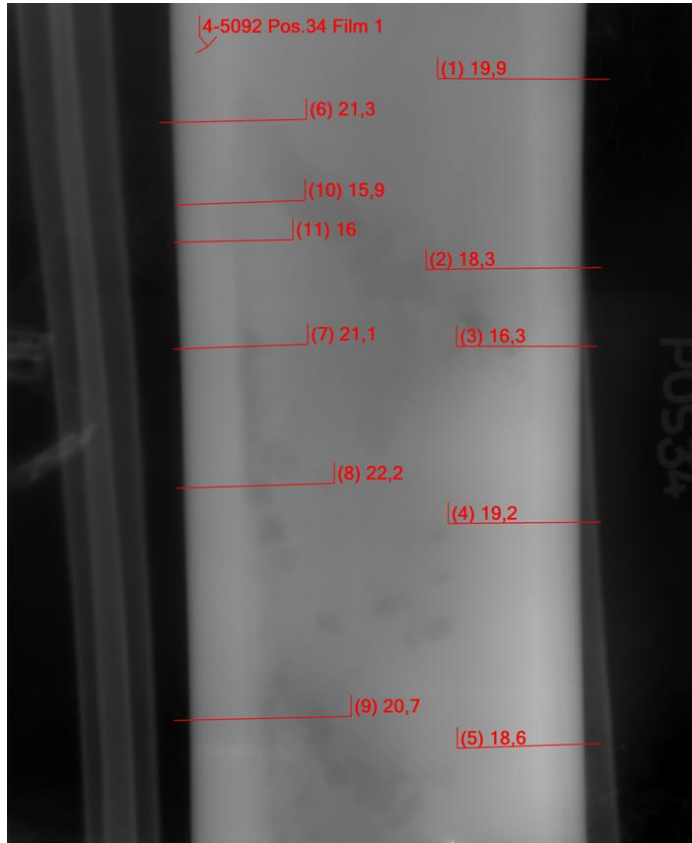
Picture 10: Digital Radiography film of the 6" pipeline

- Digital Radiography films show serious reduction of wall thickness at numerous areas.
- In about half of the films the remaining wall thickness is at minimum required level of 13 mm. In other half the minimum measured wall thickness is at 16 mm.
- The decrease in wall thickness is 7 to 10 mm! This condensation corrosion mainly occurred since the moment that the insulation has been in bad condition.
- Line is badly insulated.

Clearly one is able to see again the steam tracing lines. Also one can see the areas in the 6" pipeline with a darker grey/black color showing the areas with a smaller wall thickness. 15.9 mm is measured as the minimum wall thickness on one of these areas, which means a reduction of the original wall thickness of more than 6 mm.
