Report of Aubette Turnaround 2010

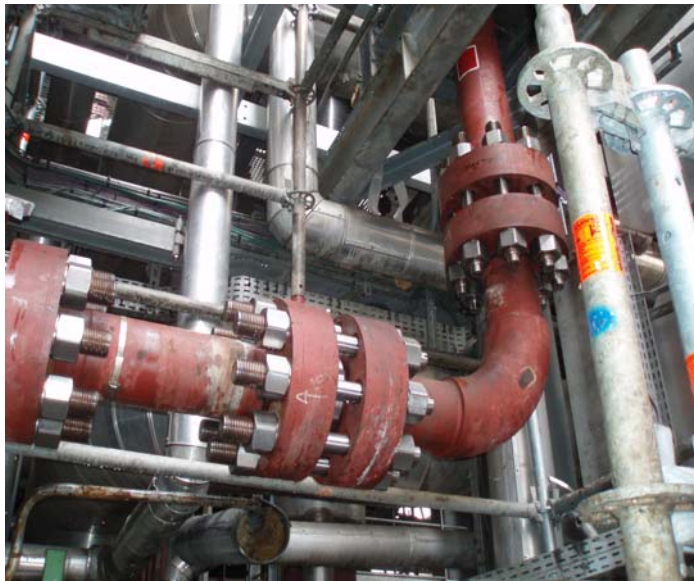
For the exchange of a special device and the add. installation of one measuring tool (process optimisation) BHDT Service was also assigned the job to completely remove a special tube, the rupture disc bloc inbetween the Preheater and the Reactor and the mixing block which

combines the two lines prior to the Reactor inlet.

This was a very critical task since the two blocks and the corresponding piping assembly are very heavy and difficult to access in the vertical orientation in which they are positioned reaching from ground floor to a height of approx. 7m.

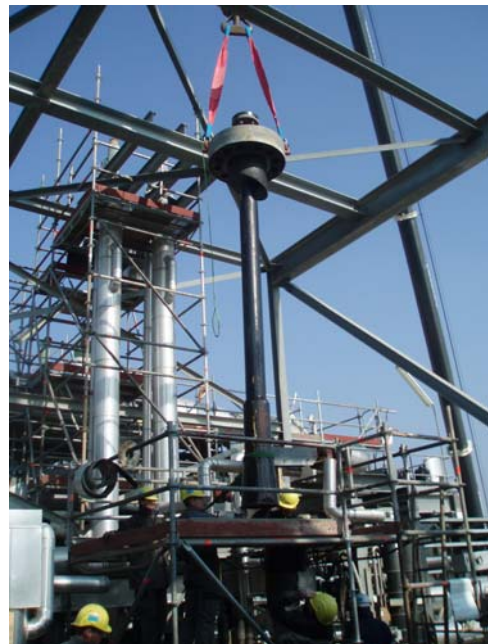
At the reactor blow down vessel – a LP vessel – the bottom man hole had to be opened for internal inspection. In addition one of the inserts from the blow off lines had to be removed for internal inspection of the insert tube which is a part of the vessel. For the pressure test of this vessel not only the bottom side man hole and the insert tube had to be blind plugged but also the top outlet which normally leads into a chimney had to be blind plugged. The chimney was therefore loosened and lifted and a blind disc with an approx. diameter of 2 m was then inserted from the side. Also several smaller sized standard ANSI flange connections for diverse inlets and outlets to the vessel had to be blind plugged for the pressure test. The pressure test was successfully performed.
